FINAL REPORT
ADVANCED STRUCTURAL REPAIR

*Design and Installation of Bonded Repairs
to cracked fuselage skins on C-5A T/N 69-021*

Contract F61708-94-C-0017

20 December 1995

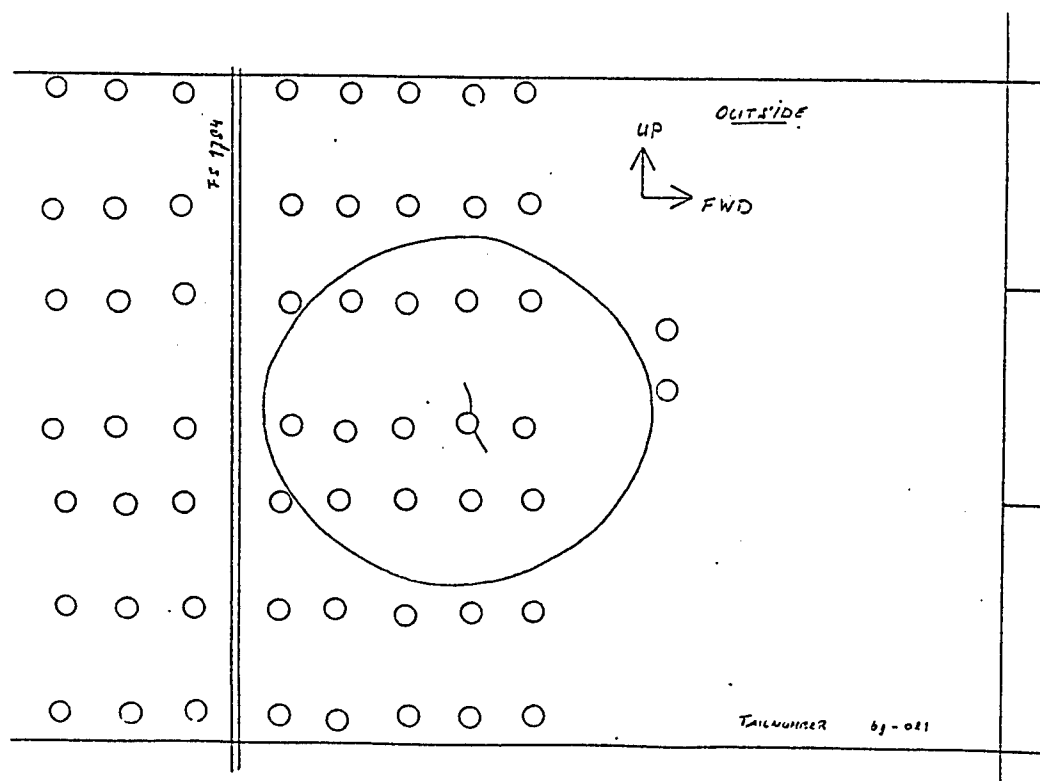
Figure 3. Trace of rivet pattern and patch location for repair to FS 1700.

Figure 3 shows a trace of the existing rivet pattern and the patch location on the aircraft at FS 1700. At the critical areas (patch tips) the rivets are all covered by the patch. By covering the rivet a high stress concentration due to the patch tip and the rivet is prevented, improving the durability of the repair system. Figure 4 shows the location of the two bonded repairs.

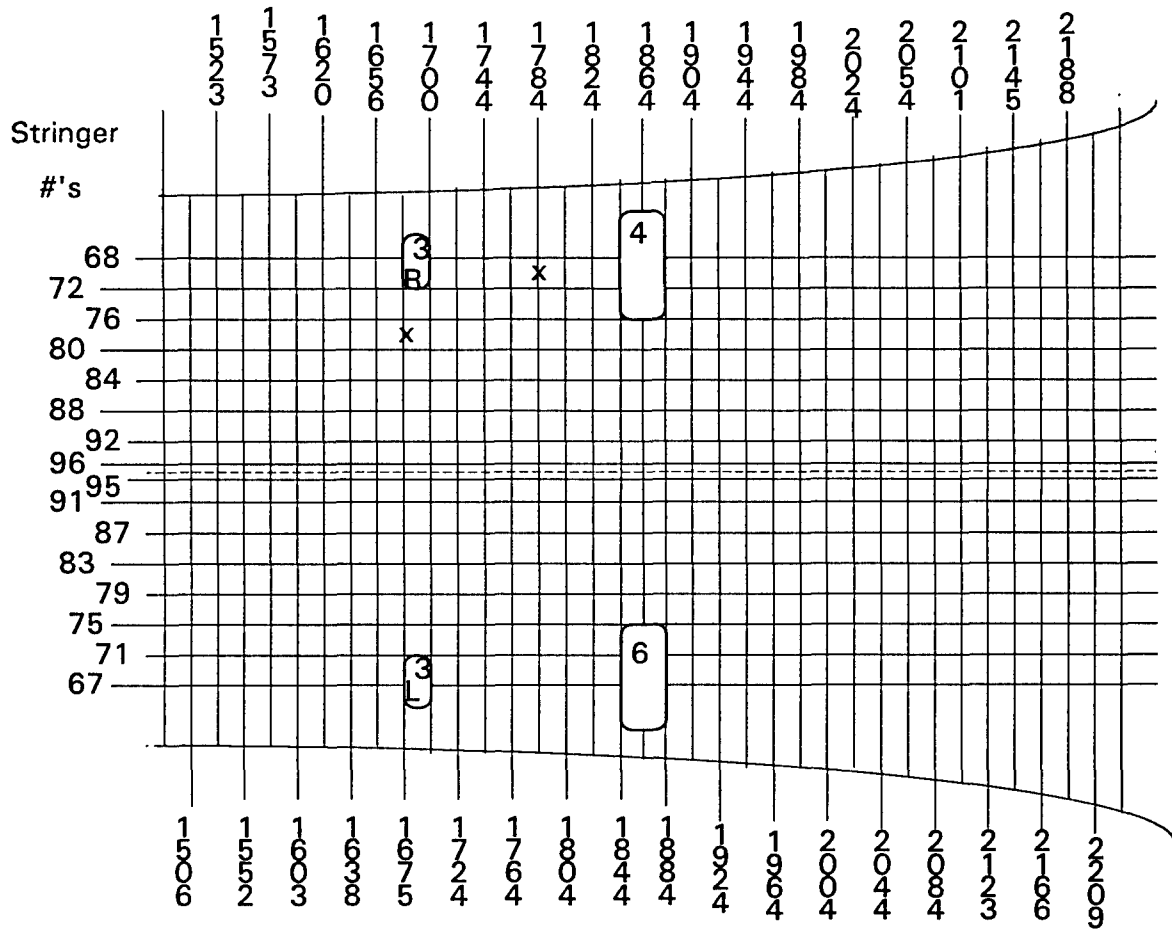
Figure 4. Location of fuselage cracks on T/N 69-021.

The two cracks repaired in T/N 69-021 are located at fuselage station 1675 near stringer 78 and at fuselage station 1784 near stringer 70. To design a suitable patch, the configuration has to meet the guidelines for typical loads, limit load and ultimate load. At typical loads the repair must show durable behavior, and greatly slow crack growth. At limit load, no yielding of any component is allowed. At ultimate design load (equal to 1.5 times the design limit load), the structure shall not fail, which means that all stresses should be less than the ultimate strength of the respective components.

1. Fuselage Station 1675
Stringer #78

2. Fuselage Station 1784
Stringer #70
